# 6075 Bumpstop Force vs. Displacement

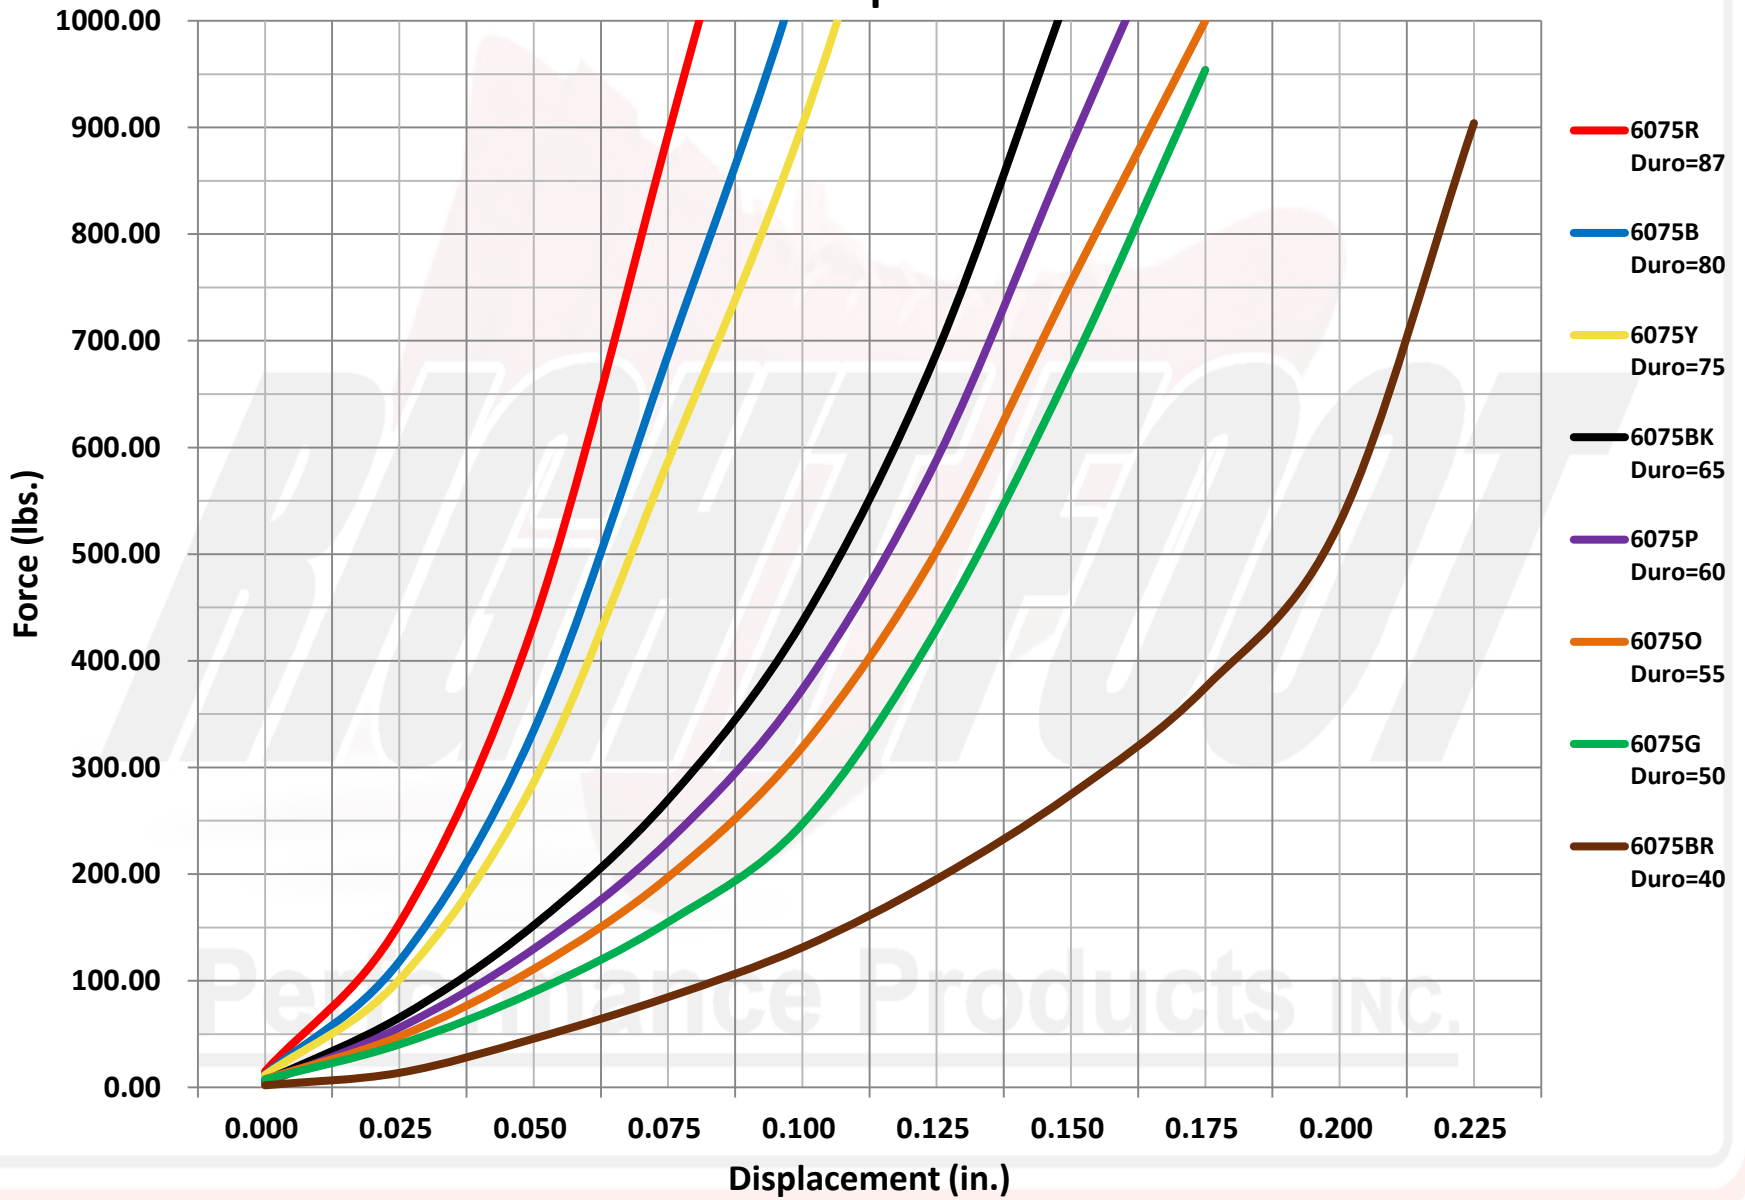
NOTE: ALL TESTED BUSHINGS WERE WITHIN  $\pm 5$  OF THE GIVEN DUROMETER
